# GREEN SWAMP NO.4 DAM

## PHASE I INSPECTION REPORT

### NATIONAL DAM SAFETY PROGRAM

NJ 00212

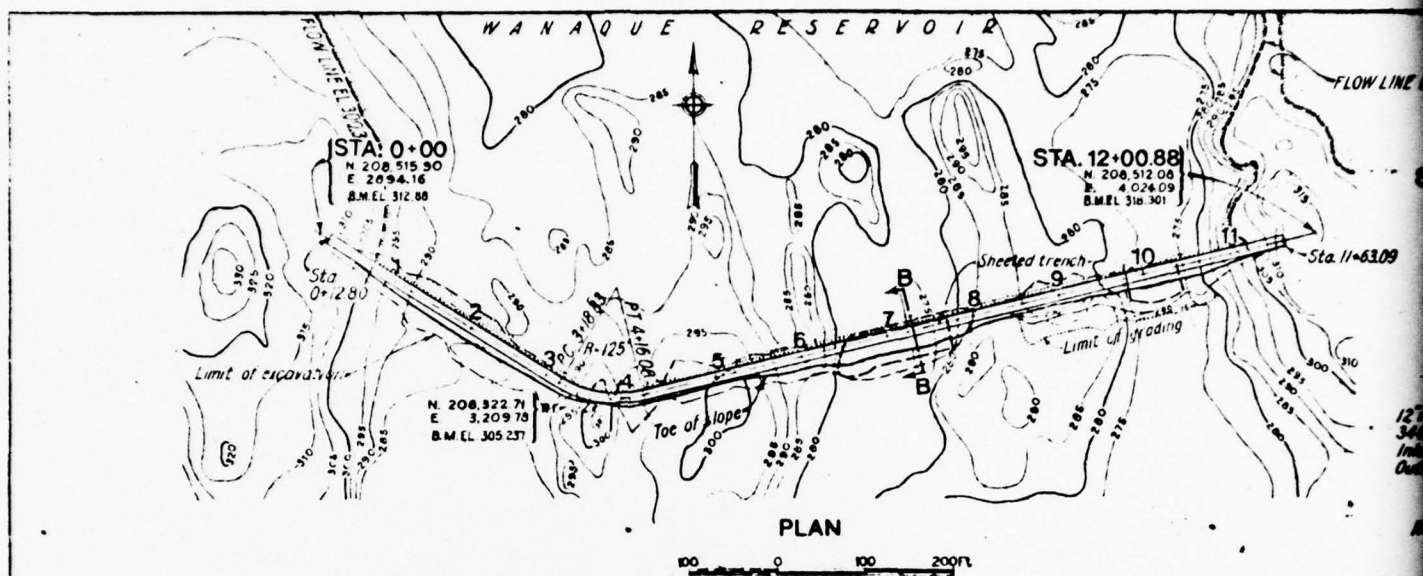
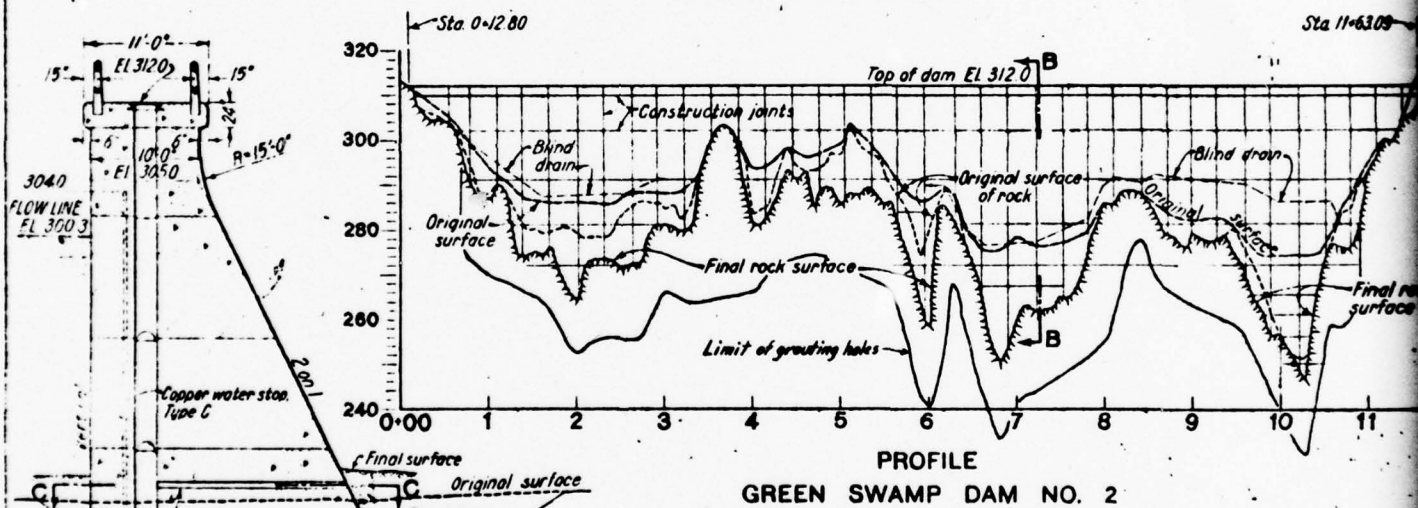
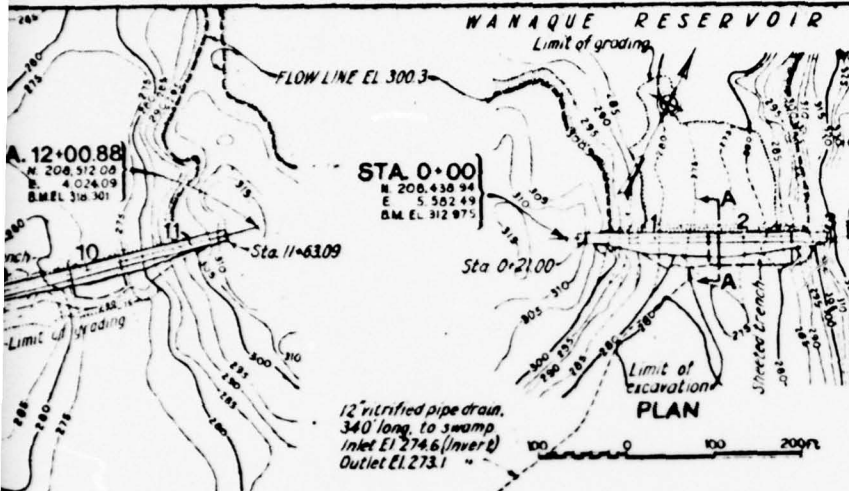
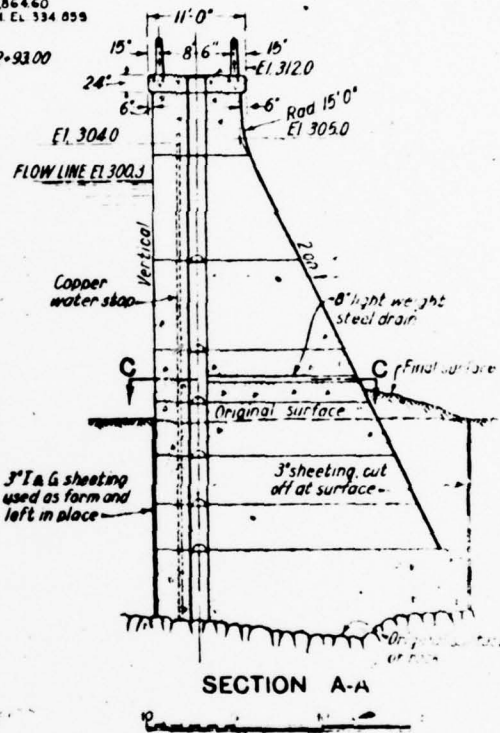
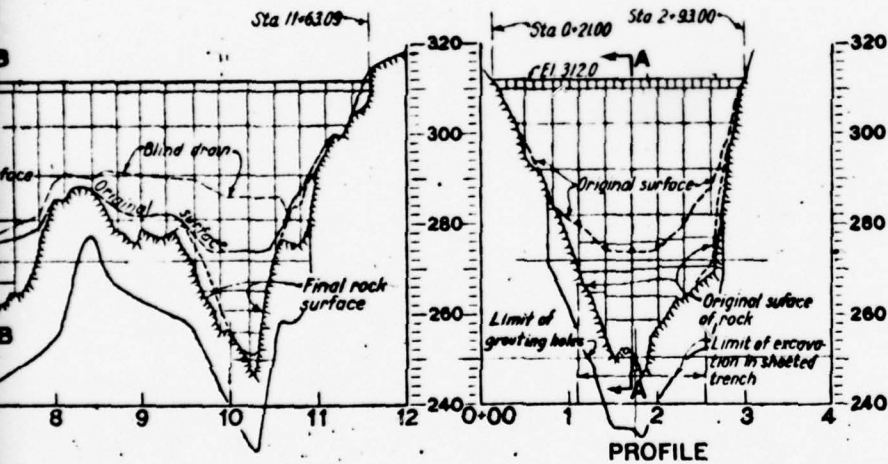
RECORD DRAWING  
SHEET 45 SHEETS IN SET 61

According to the record drawing (sheet 45 in a set of 61) the five 8-inch lateral drains which drain the water from inside the dam should exit above grade. These drains are not visible; presumably they are buried under the granular material along the toe of the dam. A high water level was noted in this material.

Record drawing sheet 45 in a set of 61 indicates that the deepest part of the foundation excavation extends down to 27 feet below original ground giving the dam a maximum height of 67 feet. Competent ledge rock at this depth had been overlain by a boulder zone (Reference 2, page 164). Grouting was performed through 626 linear feet of drill hole using a total of 623 gallons of grout consisting of 47 bags of cement (Record drawing sheet 48 in a set of 61).

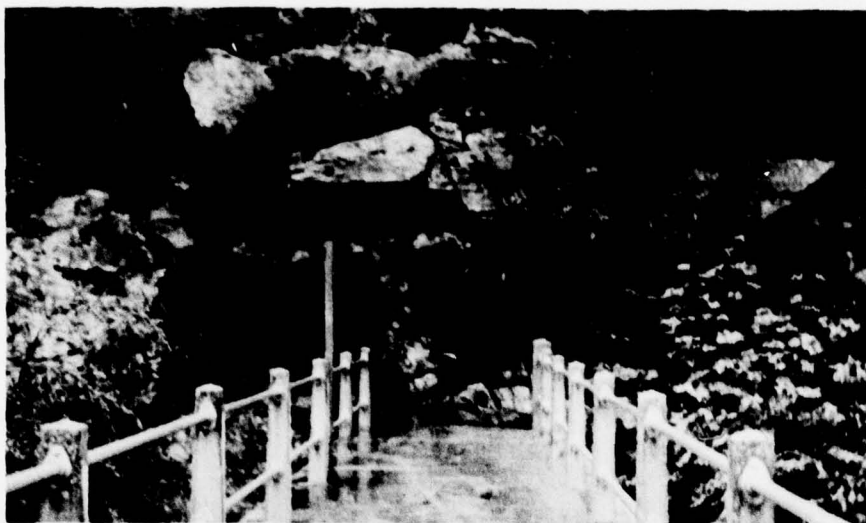
LEFT ABUTMENT

The contact between the abutment and the dam seems to be in good condition. The steep left abutment rock slope appears to be stable.
